RAIL GRADE SEPARATION TAYLORS ROAD - MELBOURNE - AUSTRALIA

Luis Agudelo

*Major Projects Division, VicRoads
60 Denmark St. Kew, 3101, Melbourne, Australia
luis.agudelo@roads.vic.gov.au*

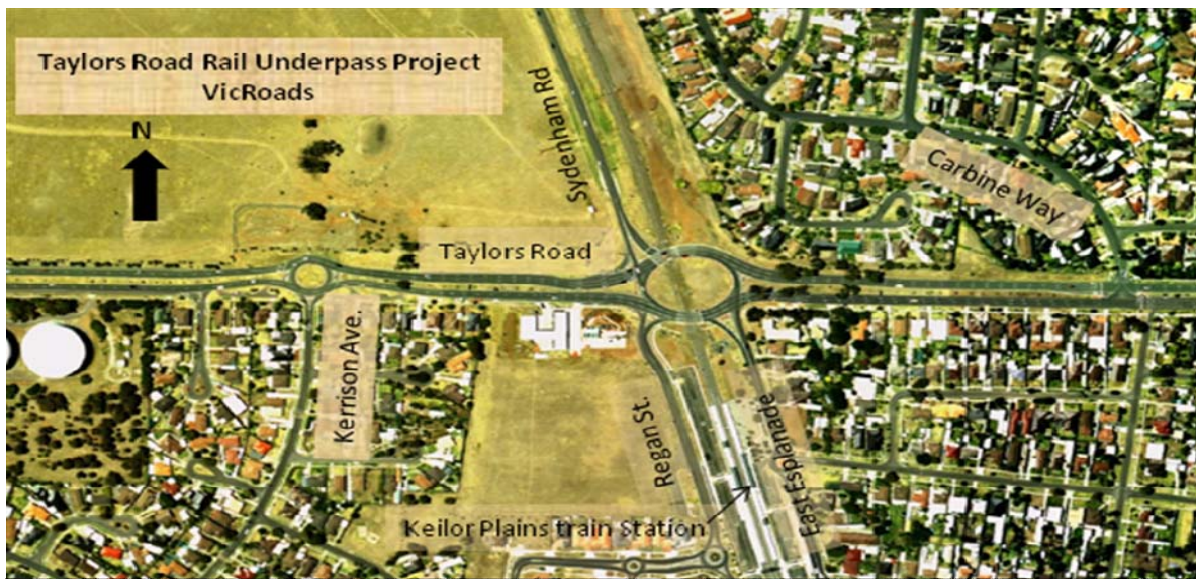
Photo 1 Taylor's Road - Aerial photo

Taylor's Road is a major east-west arterial road carrying approximately 24,000 vehicles per day (vpd) in Melbourne's north-west suburbs. The crossing of the Melbourne-Bendigo & Sydenham rail line at Taylor's Road was originally a five-leg roundabout, experiencing delays to road traffic of approximately 20 minutes every hour in morning and afternoon peak times whilst trains were crossing. Taylor's road also serves as a main utility services corridor. The photo below shows an aerial view of the project area.

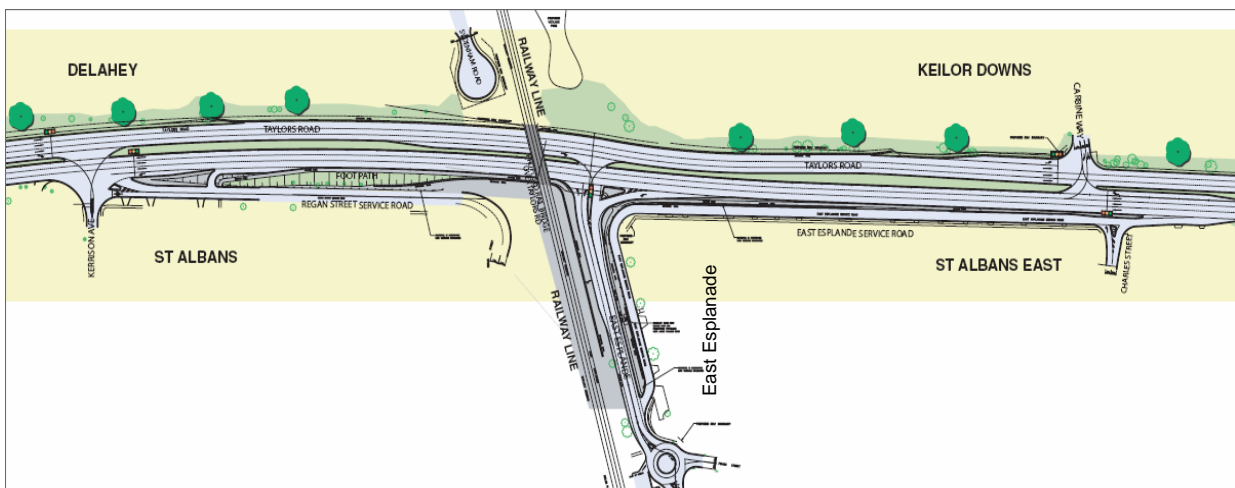
Figure 1. Alignment plan

The project involved the elimination of the roundabout and construction of a new road underpass with three lanes each way beneath the rural-metropolitan rail lines. In addition, it included the lowering of East Esplanade to Taylor's Road at a new signalised T intersection in order to maintain access to the Keilor Plains train station, the elimination of the Kerrison Avenue roundabout by the installation of a new set of traffic lights and the truncation of Sydenham Road. In order to maintain access for all residents, new service roads were constructed on Taylor's Road, East Esplanade and Regan Street. Figure 1 shows the alignment plan for these works.

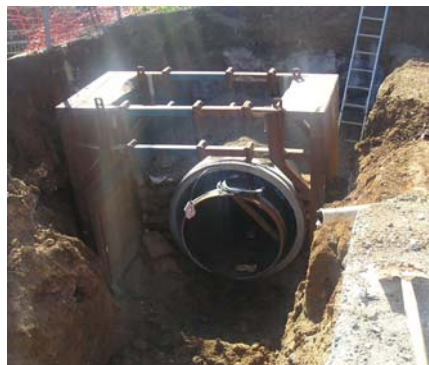
Photo 2 Encased Pipe

VicRoads engaged a contractor directly for the relocation of the CWW assets. The works started in November 2006 and the main challenge was the two bores under the railway station to cross the railway line. The rail crossing works commenced mid January 2007. Figure 4 below shows the approved design for the two encased bores under the railway station and photo 2 shows the encased pipe.

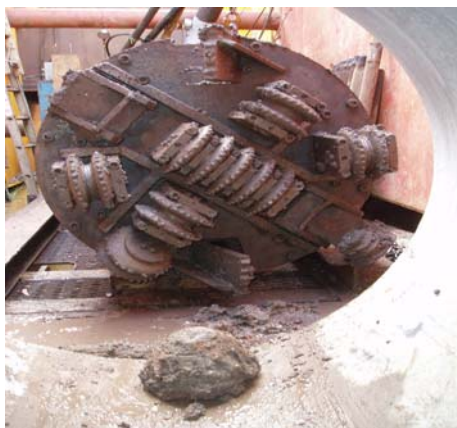
One of the challenges faced with the bore works were issues related to the water and air supply. The boring also encountered the transition between hard clay and hard rock about 10m into the first bore. The bore came to a stop when one of the two collapsible bore heads broke as detailed in photo 3. The whole bore unit had to be retrieved and taken for major repairs. The final challenge was to finish the bore without breaking the bore head again, which meant the bolts of the drive assembly having to be monitored and replaced routinely.

Photo 3 Collapsible bore head broken

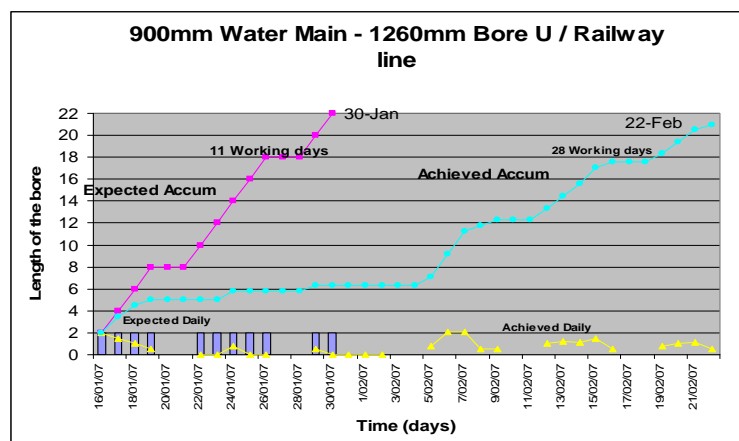
Figure 5 Expected vs. achieved graph.

Figure 5 shows the expected versus achieved program for the bore works. The bore works were expected to take only eleven days but it took a total of 28 days, almost triple the programmed period.

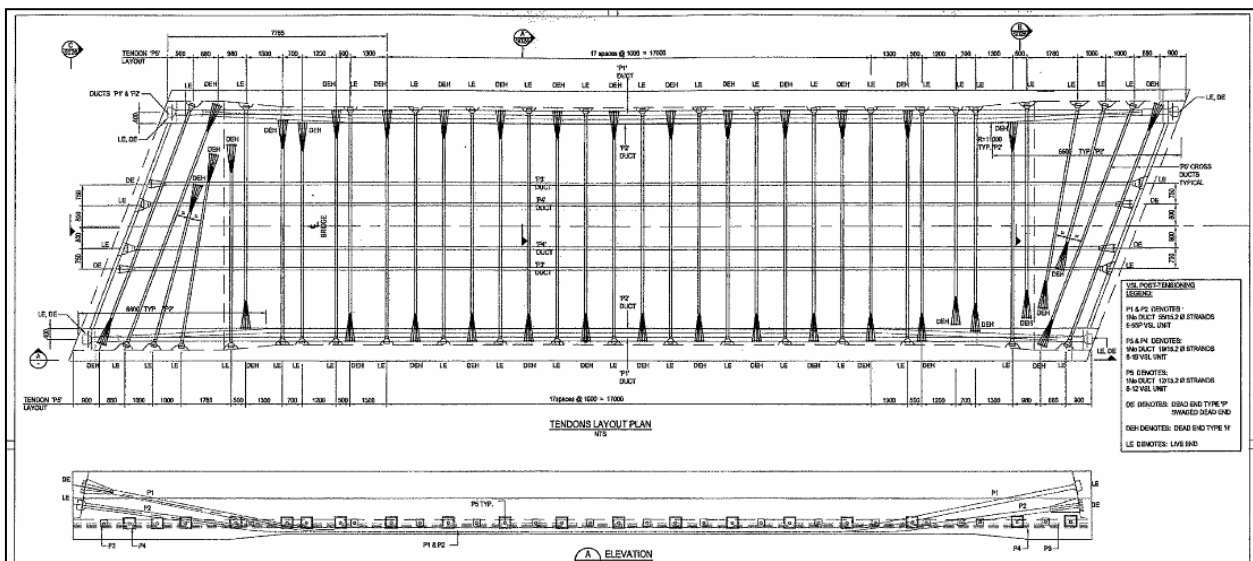
The railway bridge consisted of a single span trough girder structure which was cast-in-situ and then post-tensioned. Figure 6 shows the layout of the post tensioning tendons and figure 7 shows an isometric representation of the bridge shape. This section was chosen to minimise structural depth below the rail tracks which in turn optimised the grade line, hence reducing the amount of excavation.

Figure 6 Layout post tensioning tendons plan of the railway bridge

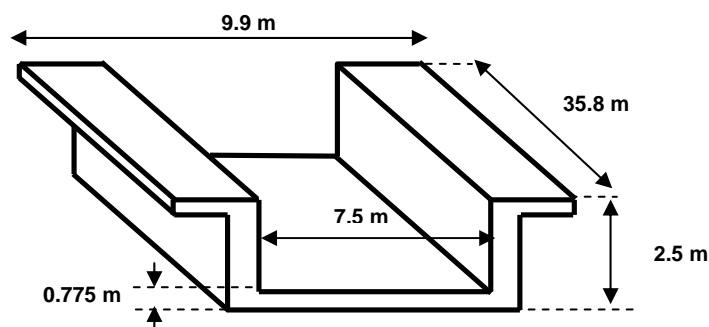
Figure 7 Isometric representation of the railway bridge

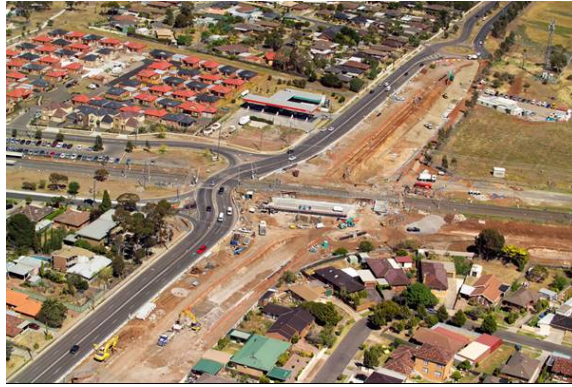
After widening works to achieve four lanes were completed, the traffic was switched south of the roundabout in June 2007 as shown in photo 4. This arrangement remained in that position until the railway bridge was constructed, jacked into position and the road underneath the bridge completed which was a period of approximately 18 months.

Photo 4 Traffic switched south of the previous roundabout & bridge under construction

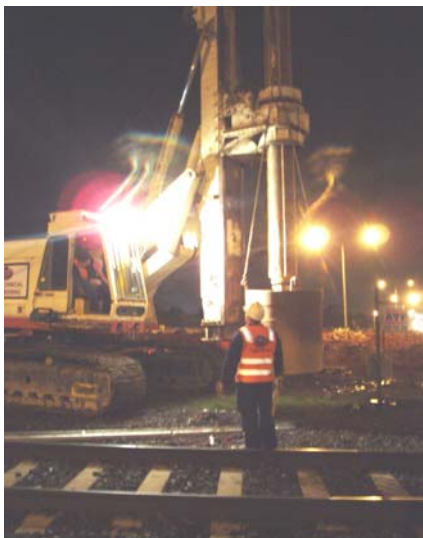
A total of twenty night occupations were used to temporarily relocate railway signals, signalling control equipment, communications cabling, fibre optics, electricity lines as well as drilling and casting of the bored piles. Photo 5 shows night works for piles installation.

Photo 5 Night bore works

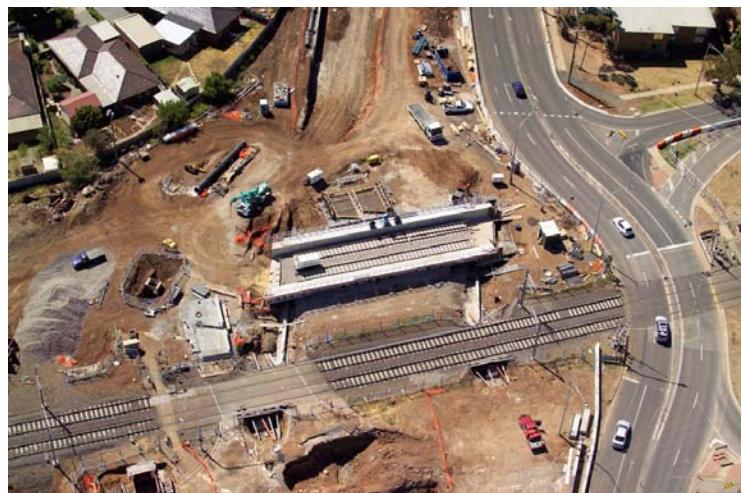
The bridge was constructed in two stages with the bottom slab being cast first and then the two vertical webs last. The approximate volume of concrete was 375m³ with a total weight of 1200 tonnes. The post-tensioning took place before the railway tracks and ballast was placed on the bridge deck at the right levels to facilitate the connection to the rail tracks off the structure after the bridge was positioned. See photo 6 showing the completed rail bridge including the rail tracks.

Photo 6 Rail Bridge completed sitting east of the railway line

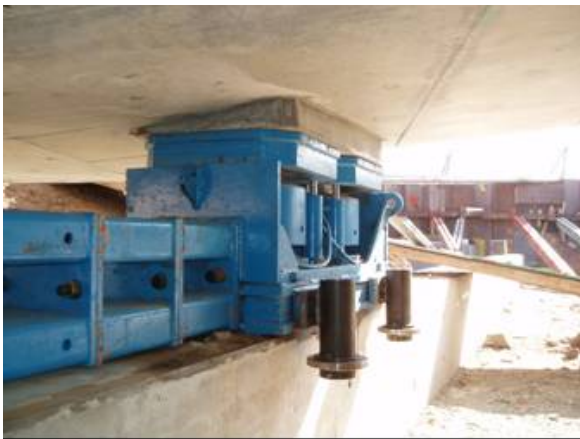
During the week prior to the occupation, the bridge was lifted around 200mm using the four vertical hydraulic jacks as shown in photo 7. Then a trial run with the 2 x 600 tonne horizontal hydraulic jacks was undertaken in order to ensure the reliability of the horizontal jacking system as depicted in photo 8. Additionally, the four bored piles had their pile caps cast to the right level for the rail bridge to be placed in its final position.

Photo 7 Vertical Hydraulic jack

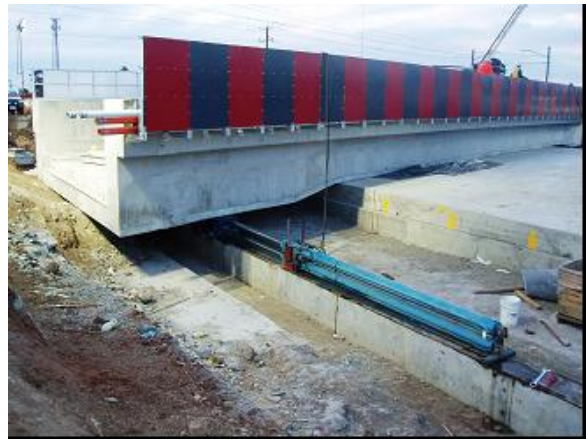
Photo 8 Horizontal Hydraulic Jack

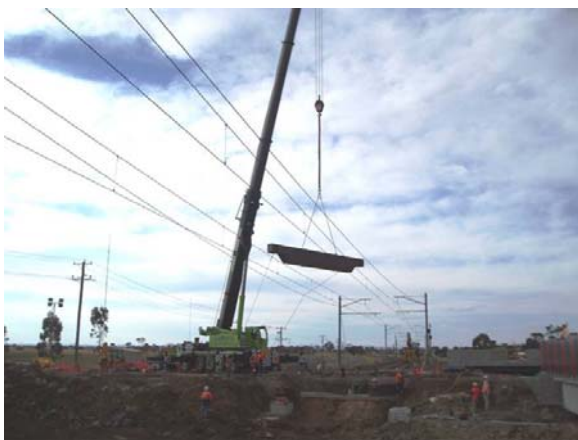
After excavation was completed, the next task was to place steel beams horizontally at the ends of the two concrete beams, which enabled the bridge to be jacked into its final position as shown in photos 9 and 10. Note the transition between the concrete and the steel beams. At around 6pm on the Saturday night, the bridge was ready to be jacked into position.

Photo 9 Steel beam being placed

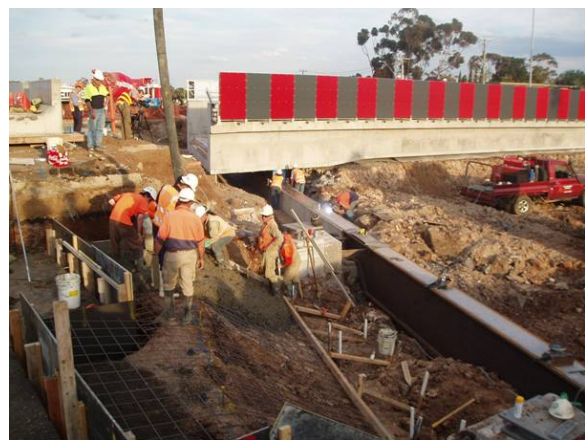
Photo 10 Steel beam placed

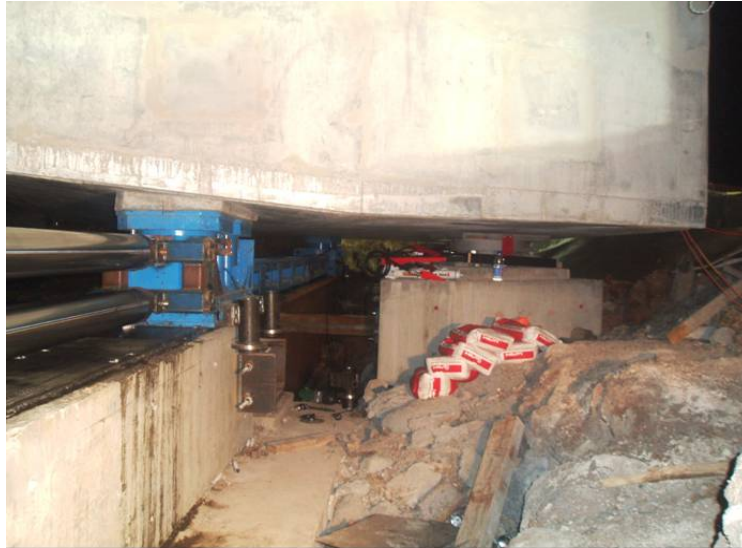
By midnight on the Saturday night the bridge had reached its final position and by 2am Sunday morning it was carefully lowered onto the pot-bearings, grouted and secured in place. See photo 11 showing the bridge on its final position ready to be grouted.

Photo 11 Bridge on its final position

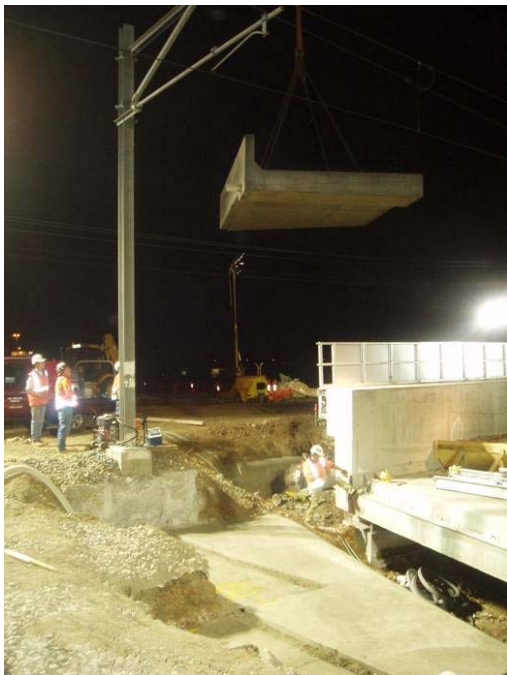
The next task was to place the bridge approach slabs into position. They were manufactured in two halves for each end of the bridge, with each half weighing approximately 14 tonnes. This design allowed for manoeuvring the slabs into position using a crane whilst avoiding the overhead power lines. Photo 12 shows the close proximity to the power lines during this operation. This task proved more difficult than anticipated, not only because of the overhead power lines but also due to the strong winds that started to affect the operation. Photo 13 shows the placement of the last half of the approach slabs by around 5.30am on Sunday morning

Photo 12 Approach Slab over the lines

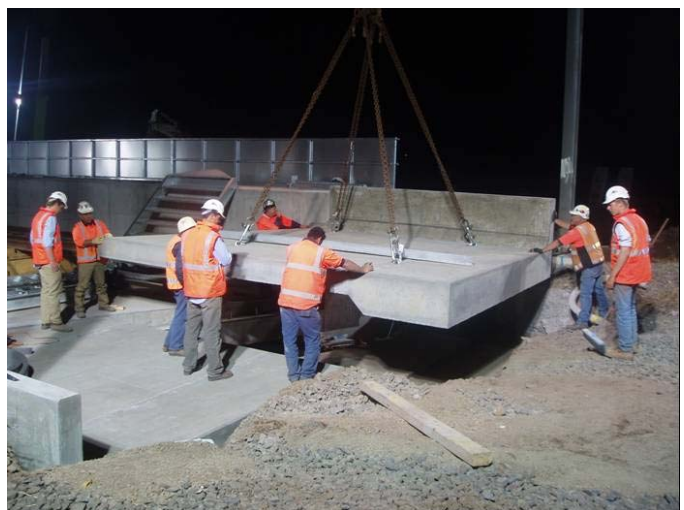
Photo 13 Approach slab being placed

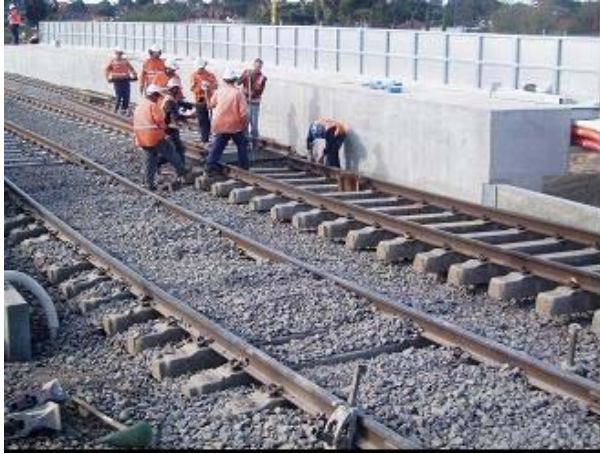
After the approach slabs were successfully placed in position, the next task was to install the missing sections of track connecting the cut off points and the section of track already in place on the bridge deck. Photo 14 shows the installation of one of the panels. Photo 15 shows the track welding works using a disposable capsule on the track, Note also the tamper attachment on the excavator in the background which has two rail axles (end & back) for easy manoeuvring on the tracks.

Photo 14 Track installation

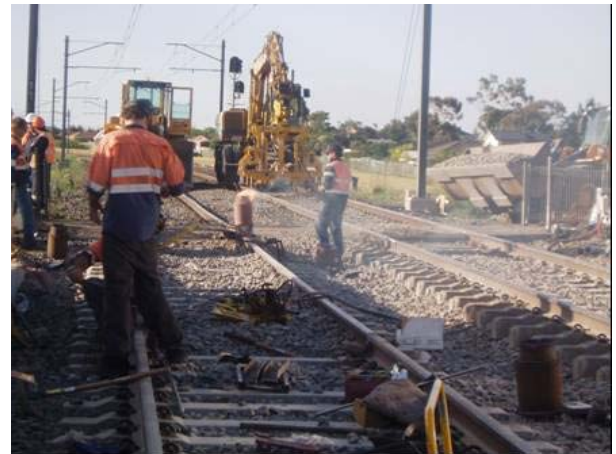
Photo 15 Track Welding and tamping operation

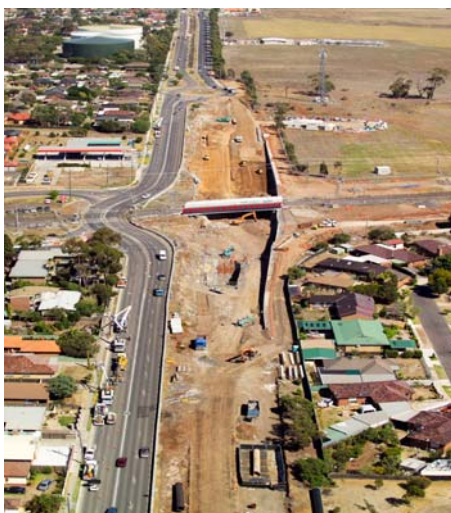
Excavation under the new railway bridge continued at the same time as the construction of the retaining walls. The excavation went down 2 metres before the first 'lift' of the shotcrete walls was undertaken. Another 2 m was then excavated and a second 'lift' of the wall was completed. The deepest part of the excavation at the bottom of the underpass was around 6 metres for a short length thus completing the northern retaining wall as shown on photo 16. Photo 17 shows the excavation works and also partial construction of the south east and south west retaining walls.

Photo 16 Overall excavation

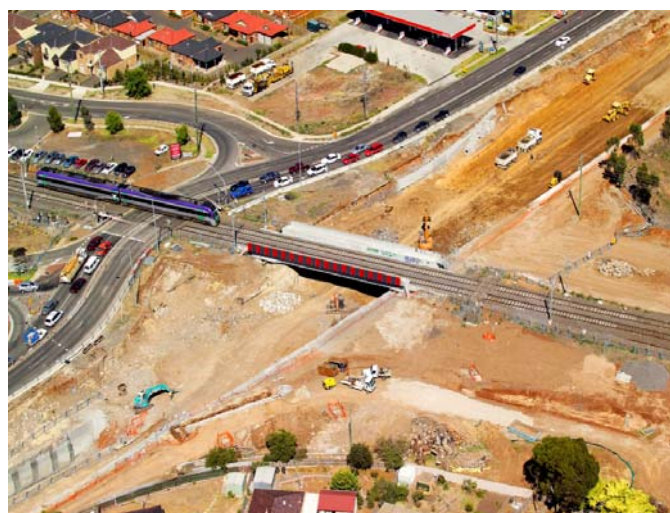
Photo 17 Excavation around the bridge area

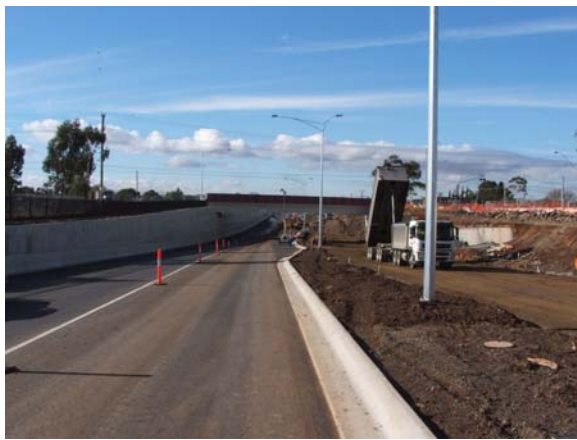
The construction of the south east and south west retaining walls were also proceeding but could not be completed until traffic was transferred under the bridge onto the new road in order to allow the excavation of East Esplanade. Traffic was transferred under the bridge in two stages. Firstly the eastbound carriageway was completed and eastbound traffic was transferred allowing additional work area to complete the excavation and further construction of the south east and south west retaining walls. This arrangement is shown in photo 18 which also shows pavement construction advancing on the other carriageway.

Photo 18 Opening to Eastbound traffic only

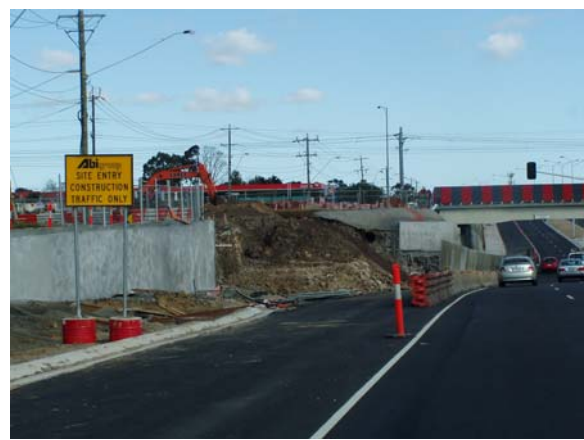
Westbound traffic was then transferred under the bridge onto the new road which enabled East Esplanade to be closed and allow the completion of the excavation and the finalising of the construction of the south east and south west retaining walls. This arrangement is shown in photo 19 looking west. Note that only two lanes of traffic in each direction were provided in order to maintain adequate access to the site using the third lane.

Photo 19 Opening to Westbound traffic

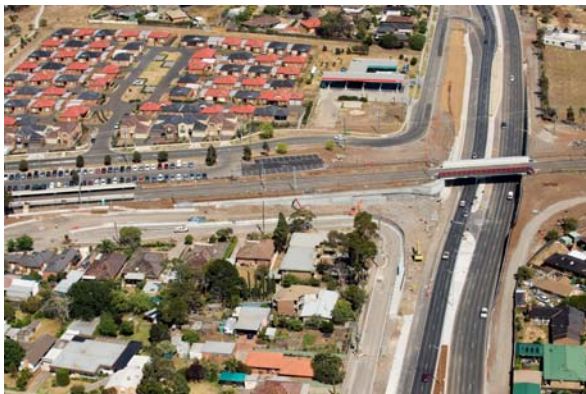
The final section of excavation on East Esplanade and completion of the SE & SW retaining walls was undertaken as the final stage of the project. Photo 20 shows the excavation works on the East Esplanade area. Access to residents along Taylors Road and East Esplanade was maintained with the use of service roads. Photo 21 shows the completed project. Note the architectural treatment on the retaining walls and the rail bridge cladding. The project was finally open to the public by the Victorian Minister for Roads and Ports in November 2008, two months ahead of schedule and with minimal disruption to rail services and road users.

Photo 20 East Esplanade Excavation
